DESTRUCTION OF TWO WATER-SUPPLY WELLS BOEING REALTY CORPORATION C-6 FACILITY LOS ANGELES, CALIFORNIA

RICHARD C. SLADE & ASSOCIATES CONSULTING GROUNDWATER GEOLOGISTS

RCS Job No. S9808

September 1998

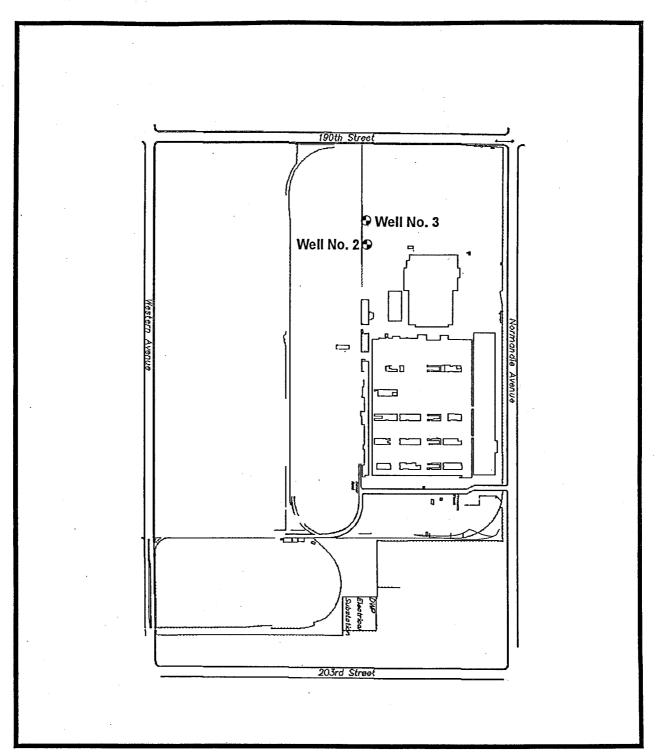
Base Map Modified from Integrated Environmental Services, Inc.

This Summary of Operations report has been prepared to document procedures and methods used in the destruction of two former water-supply wells at the Boeing Realty Corporation (BRC) C-6 Facility. This facility, as seen on Figure 1 - Site Location Map - is located on the southwest corner of the intersection of 190th Street and Normandie Avenue, in the City of Los Angeles, California. Figure 2 -Well Location Map- illustrates the approximate location of the two water-supply wells at the facility.
